Next Level Home Inspections

Customer
Jendy Lea

Address
10430 Little Bogus Creek
Montague CA 96064

Inspection Report

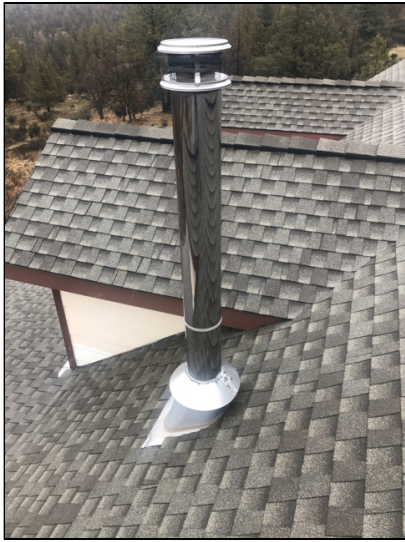
1.6 Chimney

(2) The chimney appeared to be installed correctly and functioning properly at the time of inspection there was very little creosote buildup inside of the chimney flue as well

We recommend a cleaning and level two inspection of the fireplaces and chimney flues before closing. Clean chimneys don't catch on fire. More information about fireplaces and chimneys can be obtained at www.csia.com.

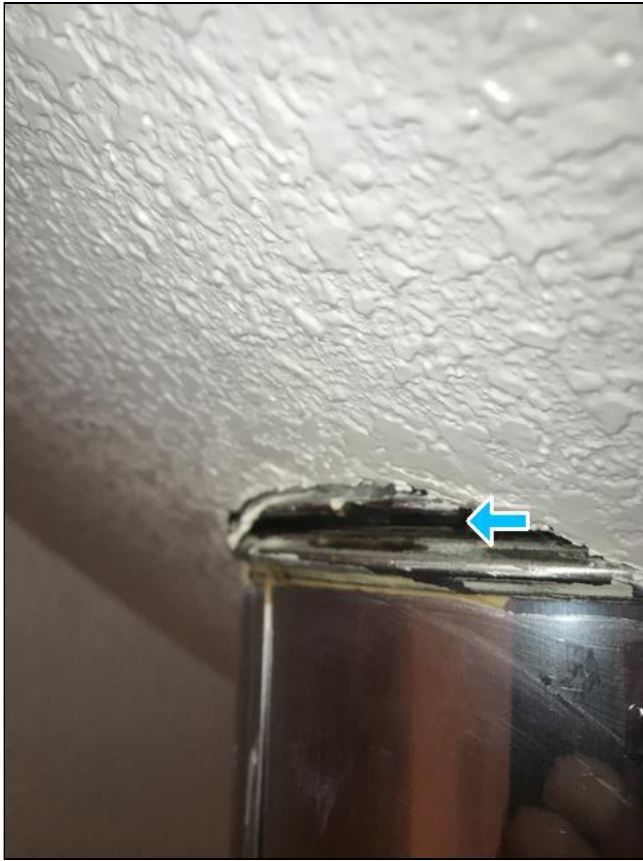
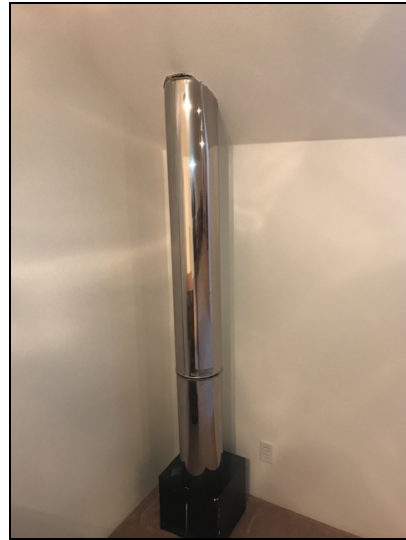
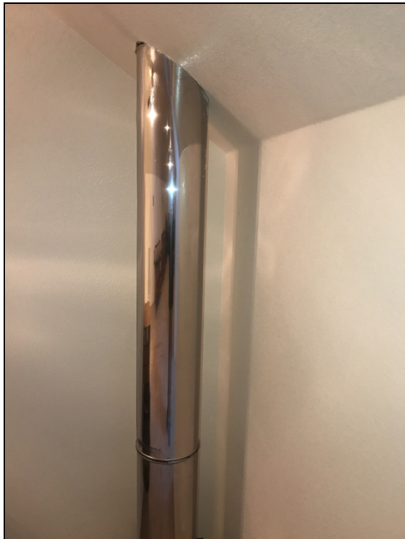
6.2 Woodstove

(1) Soot was visible on the outside of the stove pipe connection. There should also be a fire stop at each point the stove pipe passes through a wall or ceiling with a minimum of 2 inch clearance around the pipe from combustible surfaces. Recommend further evaluation by a licensed professional.

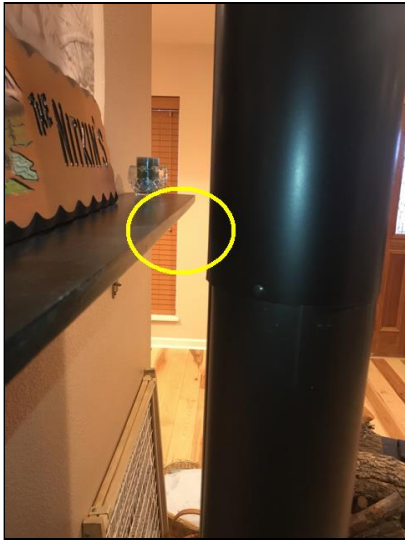
(2) Stove pipe appeared to be closer than the minimum clearance requirements to combustible surfaces. Recommend further evaluation by a licensed professional.

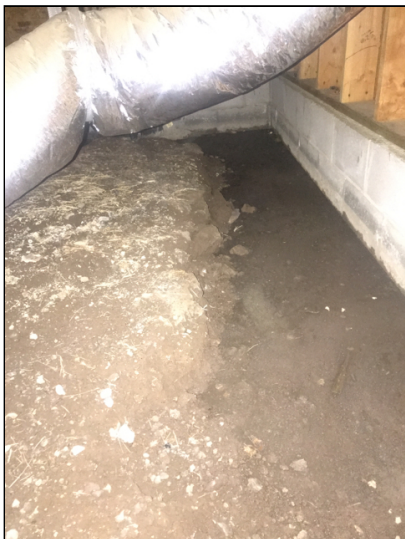
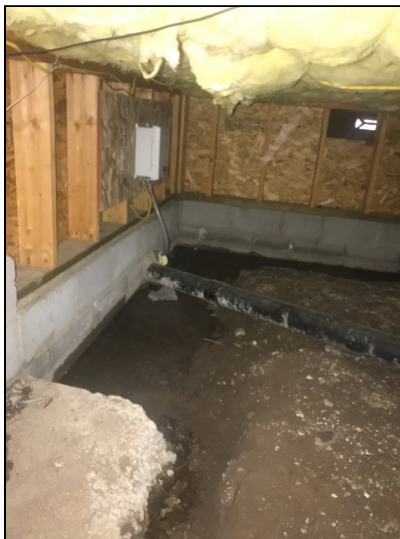
7.3 Crawlspace

There is moisture buildup in the crawlspace due to surface drainage.

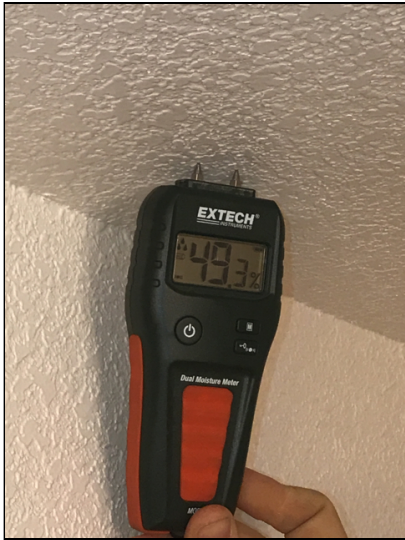
9.3 Tub / Shower

There was a leak detected under the upstairs bathroom with an infrared camera and confirmed with a moisture meter. Because of the cooler temperatures of the walls, we ran hot water which can be seen in the infrared picture. Recommend correction by a licensed plumber.

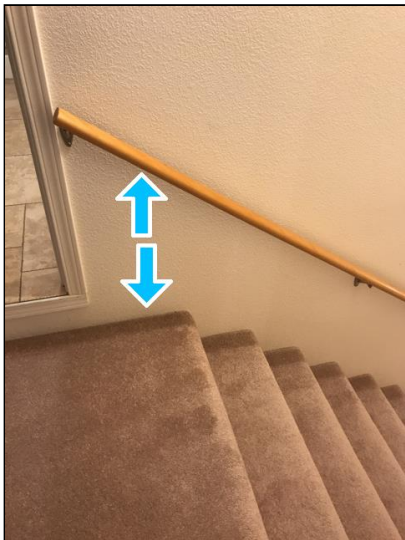
14.4 Railings / Balconies

Railing was an inconsistent height. It was too low at the top of the stairs. Recommend correction by a licensed contractor.

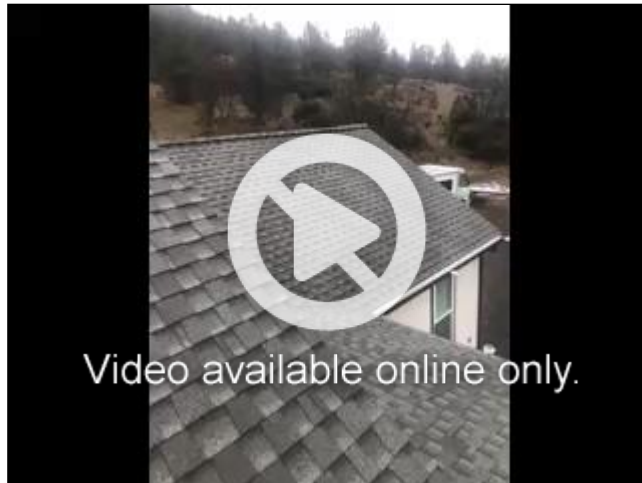
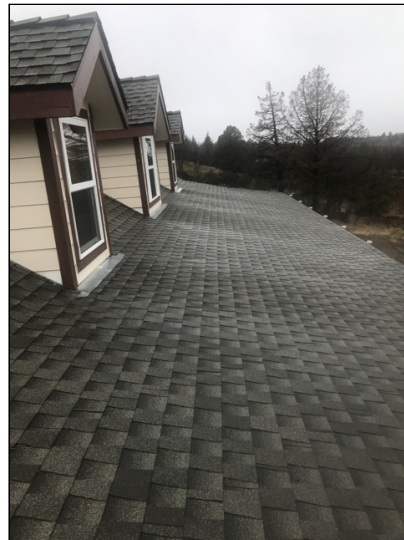
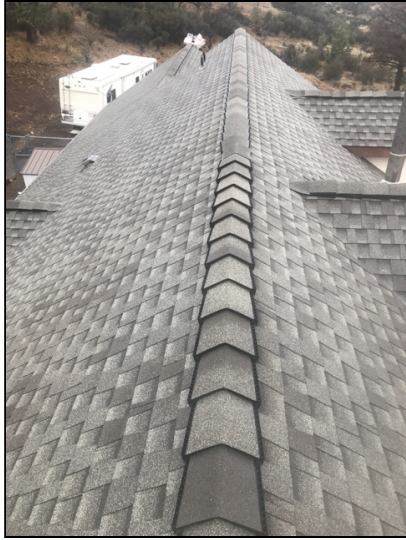
The overall condition of the roof covering was good at the time of inspection.

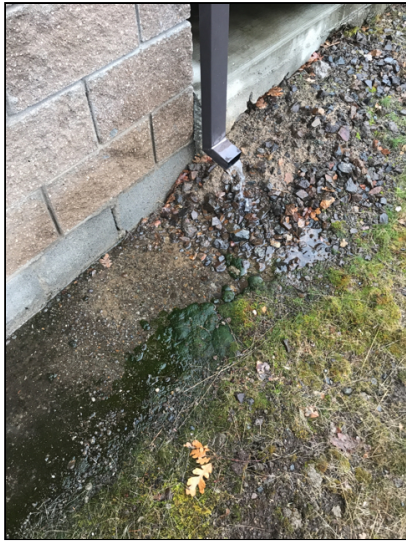
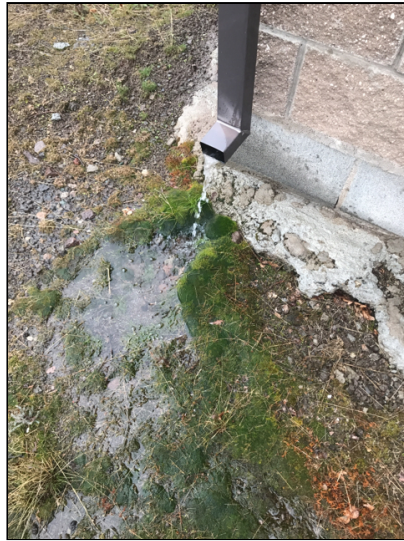
1.1 Gutters

Some of the gutters drain near the foundation of the front porch. Recommend adding extensions to take water away from the structure.

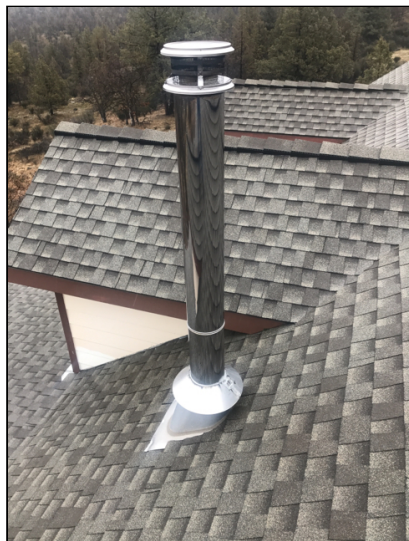
(2) The chimney appeared to be installed correctly and functioning properly at the time of inspection there was very little creosote buildup inside of the chimney flue as well

We recommend a cleaning and level two inspection of the fireplaces and chimney flues before closing. Clean chimneys don't catch on fire. More information about fireplaces and chimneys can be obtained at www.csia.com.

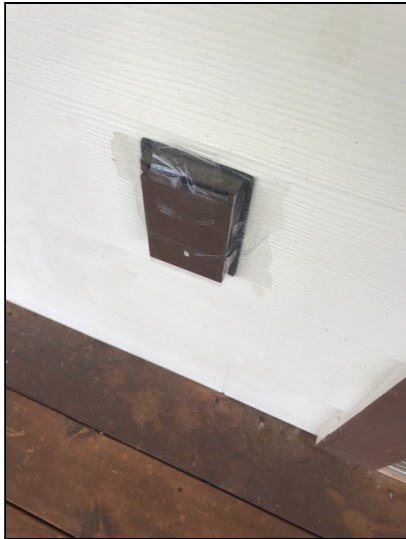
Outlet was tapped shut.

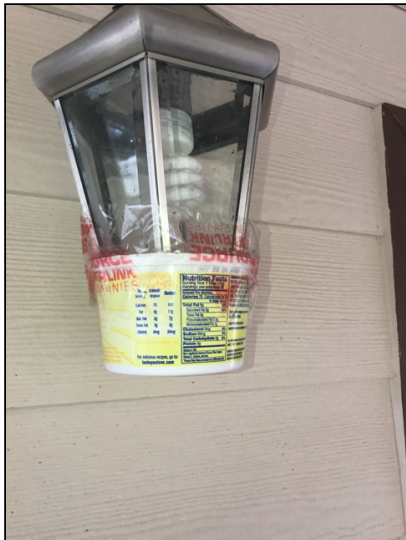
2.6 Light Switches and Fixtures

(1) Fixture was sealed off with a butter container and tape. Possibly to protect it from bugs while house was empty.

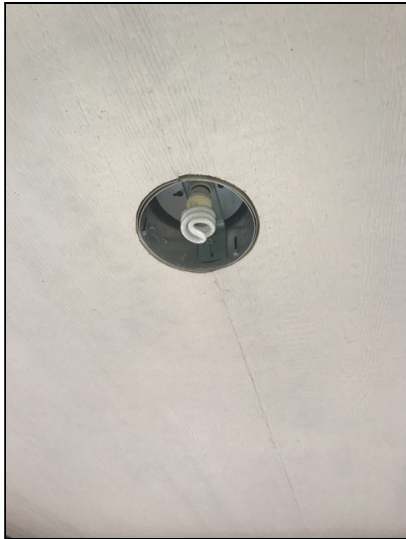
(2) Some of the deck lights were missing the trim pieces.

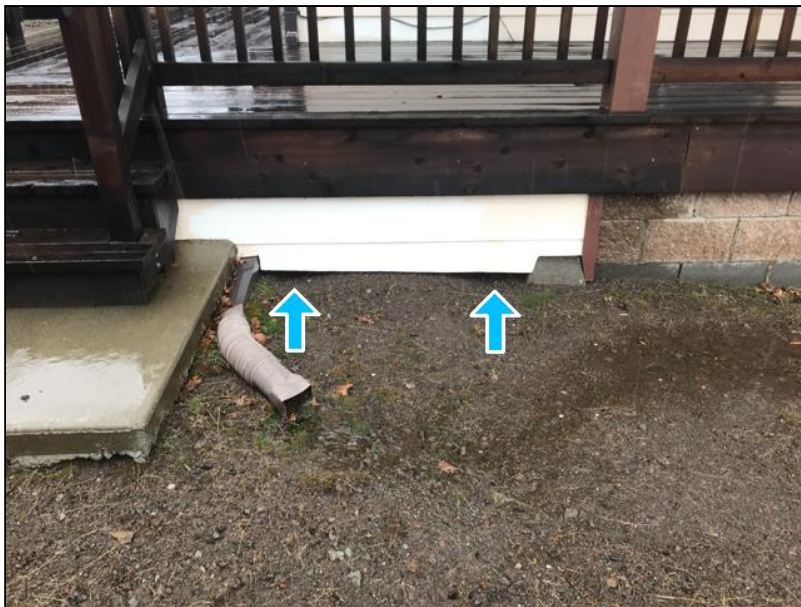
There were some potential entry points for animals to get underneath the deck. Recommend having these areas sealed.

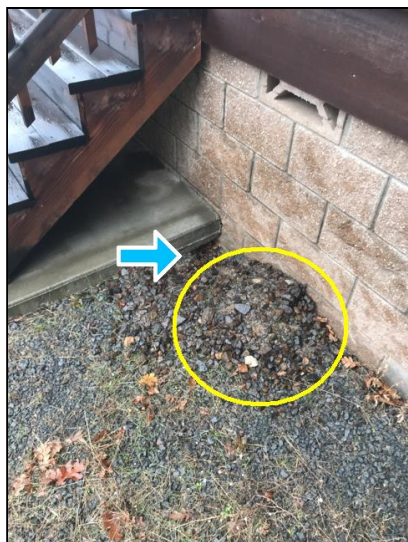
3.0 Foundation

Signs of possible animal intrusion digging under front steps slab. Recommend further evaluation by a licensed pest control.

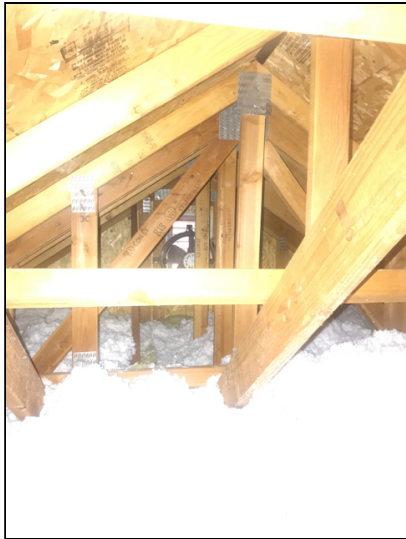
The overall structure of the roof was good at the time of inspection.

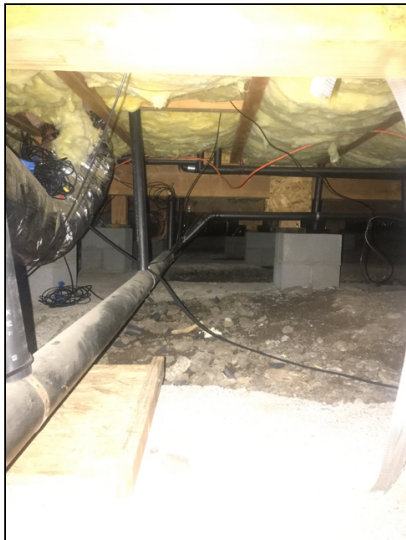
3.5 Columns / Piers

All of the columns and piers look good at time of inspection. The house was well supported, no signs of sinking or shifting.

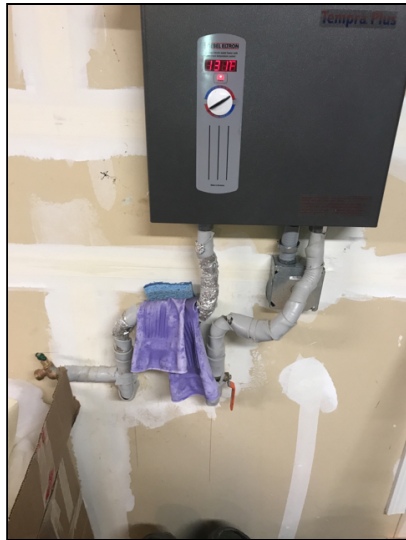
Tankless water heaters will need occasional flushing to remove build up on the inside of the pipes. Typical installation of tankless water heaters should include valves that aid in flushing the unit.

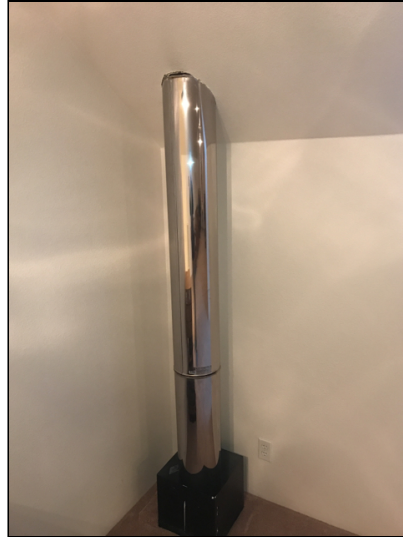
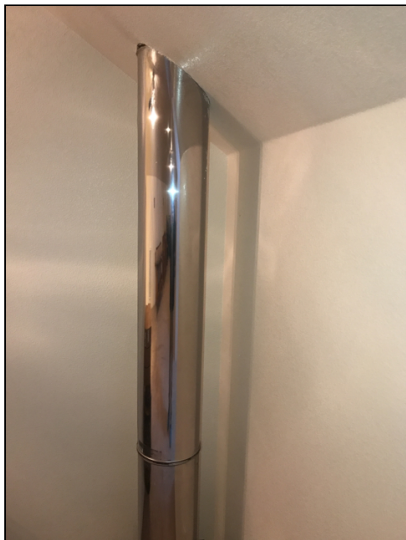
(1) Soot was visible on the outside of the stove pipe connection. There should also be a fire stop at each point the stove pipe passes through a wall or ceiling with a minimum of 2 inch clearance around the pipe from combustable surfaces. Recommend further evaluation by a licensed professional.

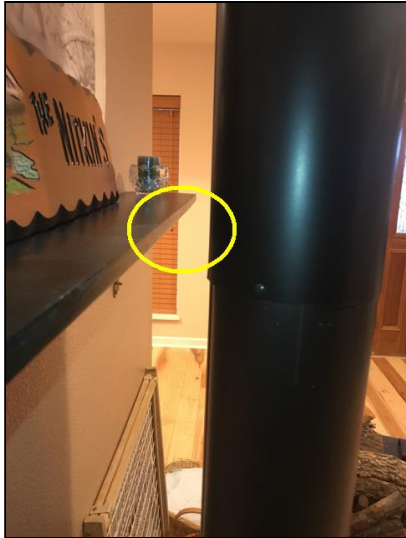
(2) Stove pipe appeared to be closer than the minimum clearance requirements to combustibles surfaces. Recommend further evaluation by a licensed professional.

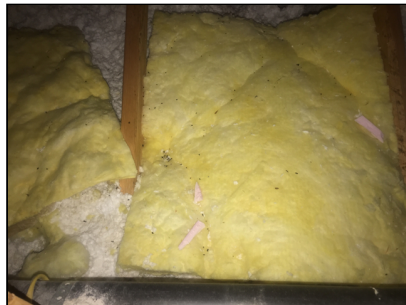
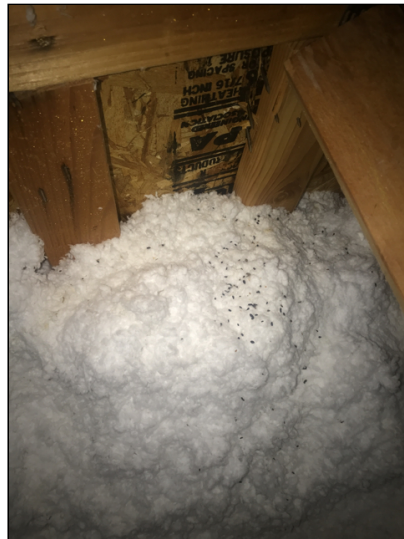
(1) There was evidence of rodents in the attic space. Recommend further evaluation by a licensed pest inspector.

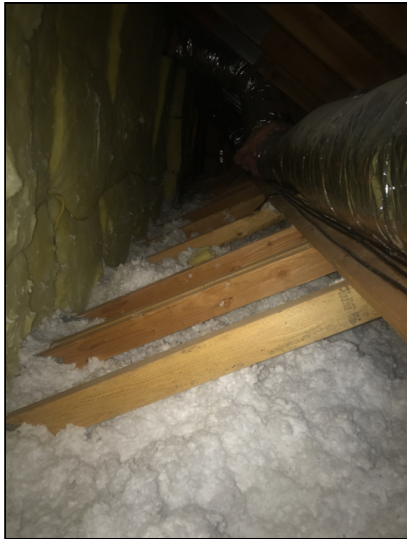
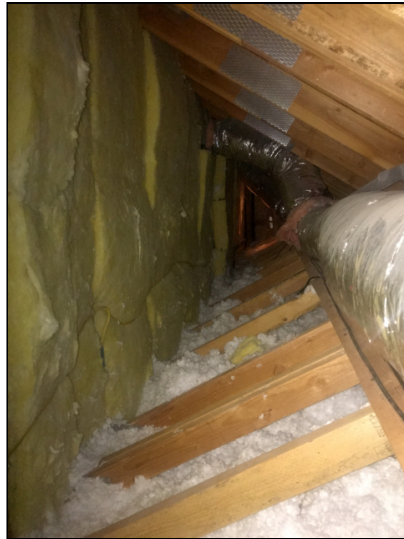
(2) The attic space is well ventilated and well insulated.

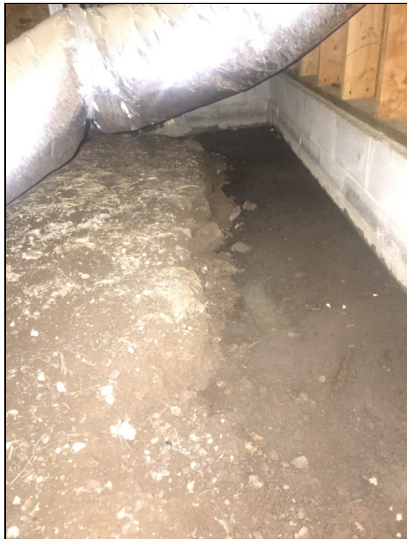
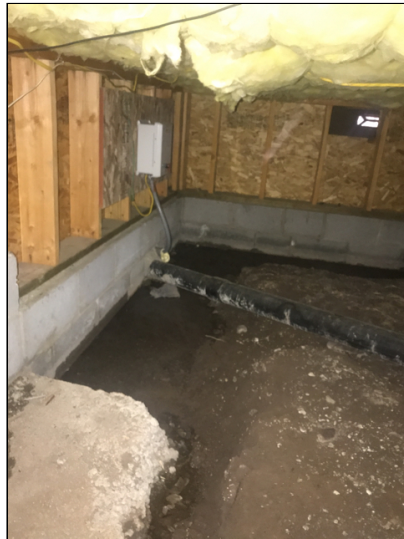
There is moisture buildup in the crawlspace due to surface drainage.

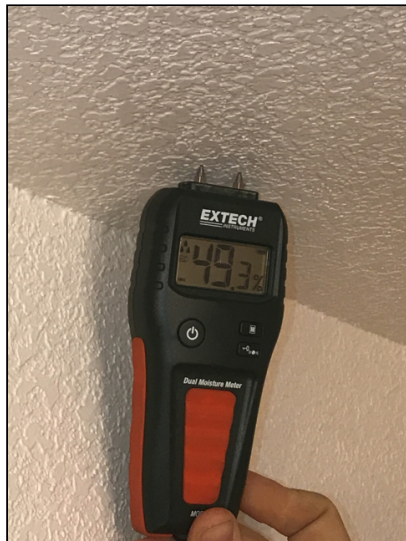
There was a leak detected under the upstairs bathroom with an infrared camera and confirmed with a moisture meter. Because of the cooler temperatures of the walls, we ran hot water which can be seen in the infrared picture. Recommend correction by a licensed plumber.

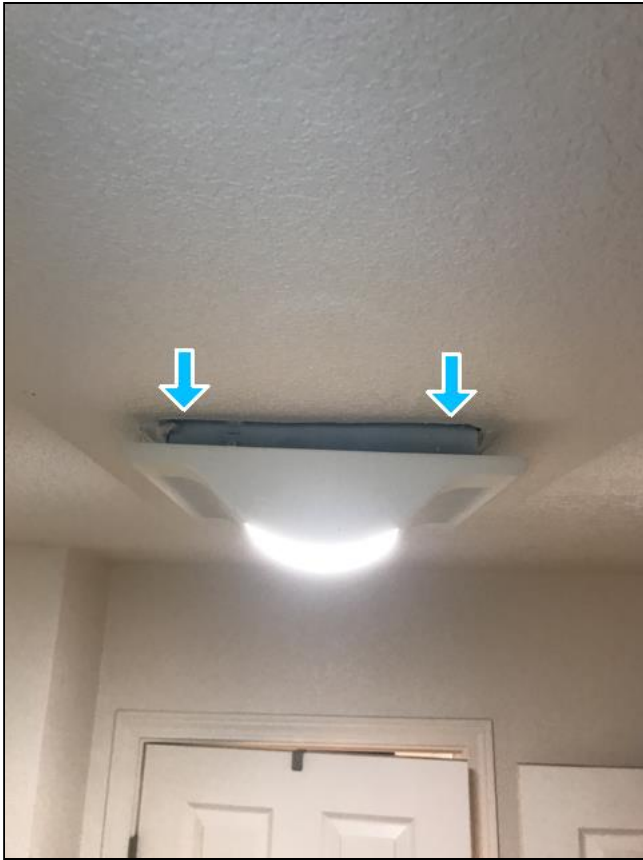
Vent light fixture was not mounted flush to the ceiling.

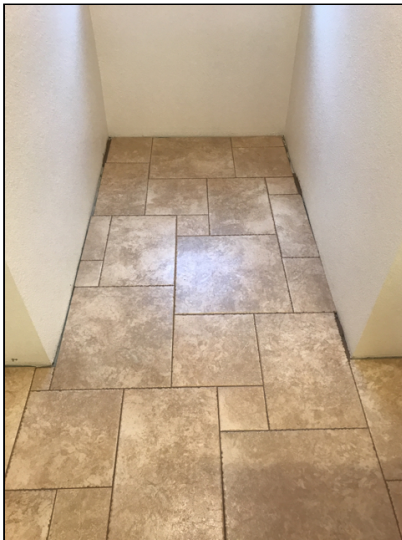
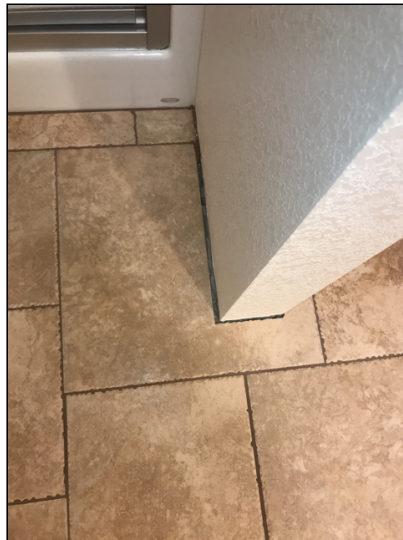
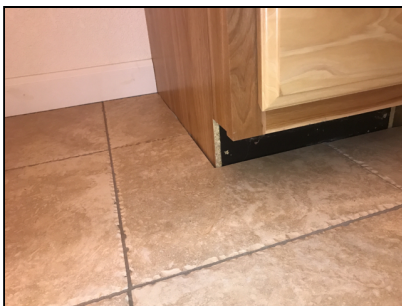
Upstairs bathroom and master bathroom appeared to have new tile installed and lacked baseboards in some sections.

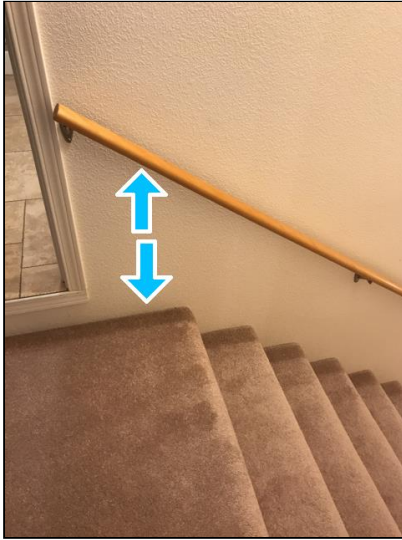
Railing was an inconsistent height. It was too low at the top of the stairs. Recommend correction by a licensed contractor.

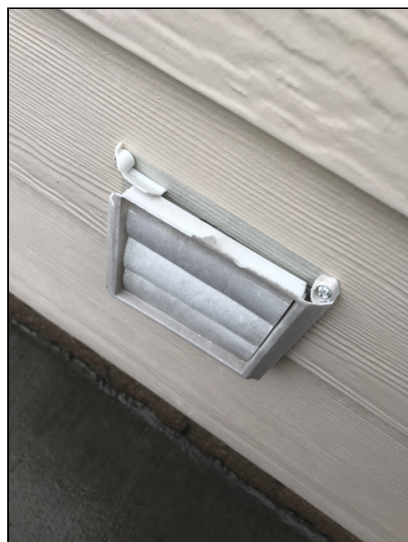
Vent cover was brittle and cracking. Recommend having it replaced.
